CITY OF NEW ORLEANS

Historic District Landmarks Commission

Guidelines for Masonry and Stucco

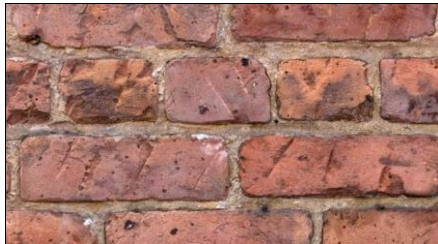
19th Century Brick –A soft, fired-clay, fairly regularly shaped building component; often with color and surface variations; used primarily in walls, piers, foundations and exterior pavers.

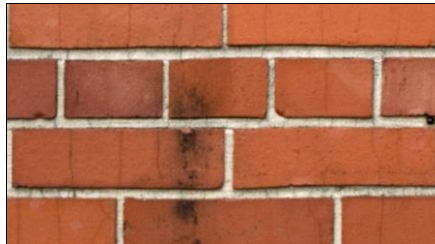
20th Century Brick –A hard, dense, fired-clay, regularly shaped building component; sometimes with a glazed surface; used primarily in walls, piers, foundations and exterior pavers.

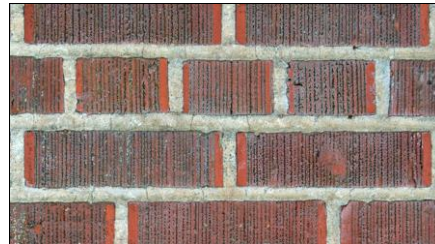
Wire Cut Brick –A dense, fired-clay, regularly shaped building component; with a ridged surface; used primarily in 20th century building walls.

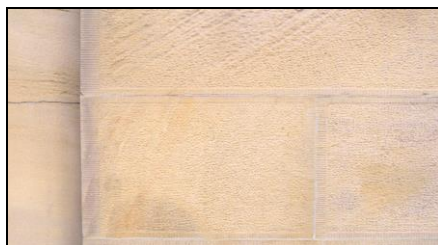
Limestone – A sedimentary rock; used for building walls, window sills and lintels, ornamental stone trim, sculpture and for producing lime.

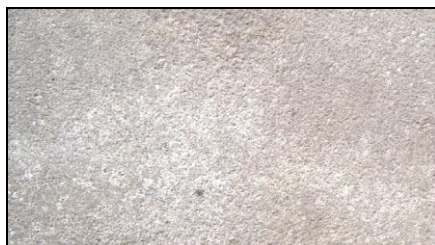
Granite – A hard rock, consisting of small, yet visible, grains of minerals, which can be highly polished or textured; used for walls, piers and street curbs; commonly in gray, black and pink.

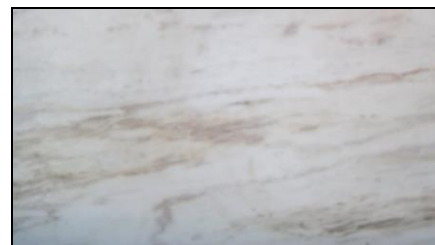
Marble – Typically fine grained and able to be highly polished; it has a wide range of colors and patterns; used for steps and stoops, statuary and fine masonry.

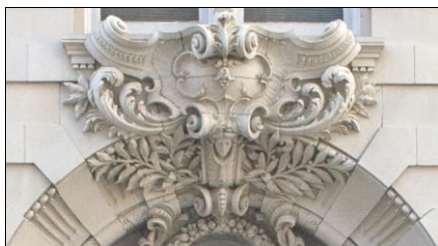
Terra Cotta – Fired-clay, non-structural building components, often with colored glaze, used for decorative, ornate details and wall finishes.

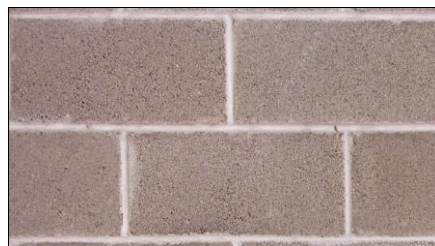
Concrete Block – A structural building material made by mixing water, cement, sand and aggregate, placing the mix in forms and hardening; commonly used for foundations, walls and piers.

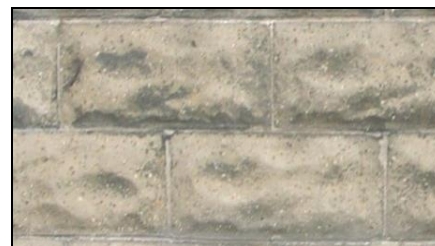
Textured Concrete Block – A structural building material made by mixing water, cement, sand and aggregate, placing it in forms and hardening; commonly used for foundations, walls and piers, popular in the early to mid-20th century.

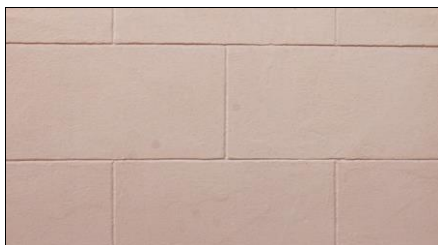
Scored Stucco – Smooth finish with scoring to simulate stone joints.

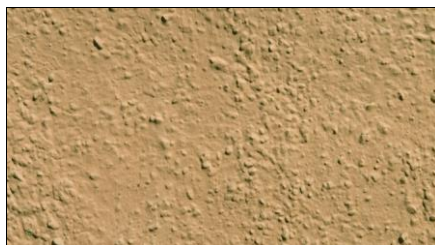
Dash Finish Stucco – Textured finish with pronounced aggregate at the surface.

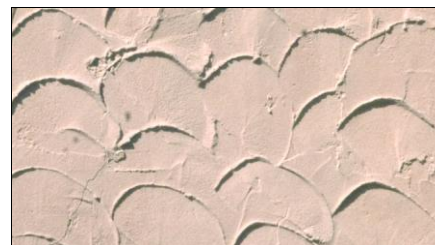
Trowel Finish Stucco – Highly stylized finish with pronounced ridges and shadows from trowel application.

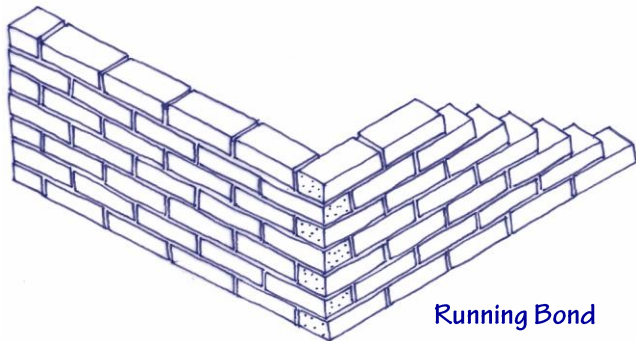
Running Bond

The most frequently constructed brick bonding pattern is common bond, which is built of stretcher courses with header course every sixth row. Another familiar bonding pattern is running bond, comprised only of stretcher courses.

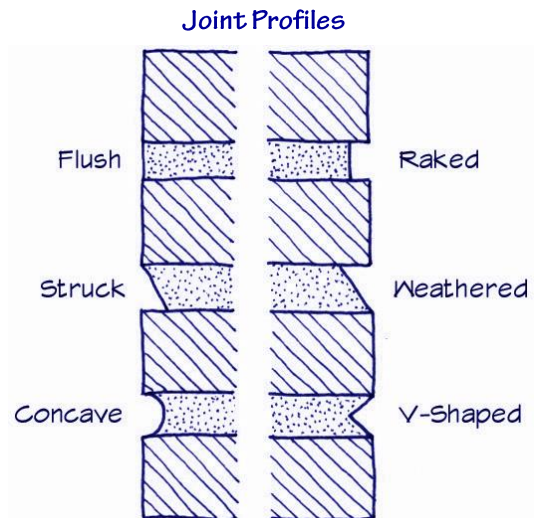
There are numerous joint profile types, with each producing different shadow lines and highlights. When repointing an area of masonry, it is important to tool the mortar to match the existing joint profile for a consistent appearance.

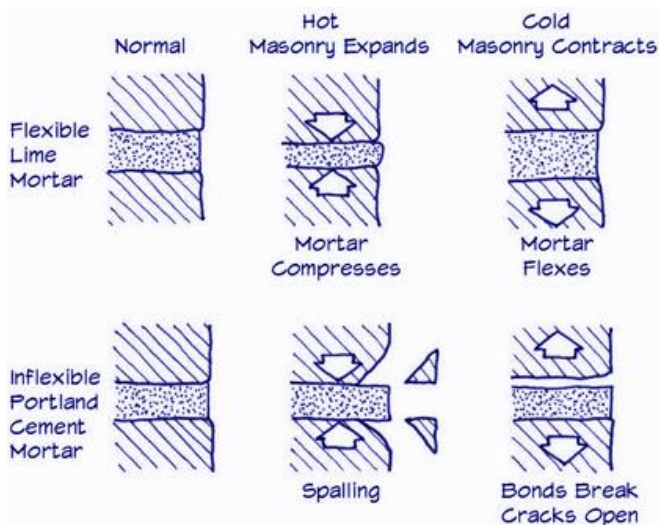
MORTAR HARDNESS AND MASONRY

Temperature changes cause masonry units to expand when heated and contract when cold. The expansion and contraction of the masonry units results in compression and flexing of the adjacent mortar joints.

Lime based mortar is pliable and is more likely to compress and flex through temperature cycles. If properly installed, it should also be softer than the adjacent masonry.

Portland cement based mortars are significantly harder than lime based mortars and far less elastic. In addition, cement mortars tend to be substantially harder than historic masonry. When masonry units expand in warm temperatures, they press against the harder cement mortar and tend to spall at the edges. During colder temperatures, masonry units tend to pull away from mortar, resulting in open cracks that can allow moisture penetration.

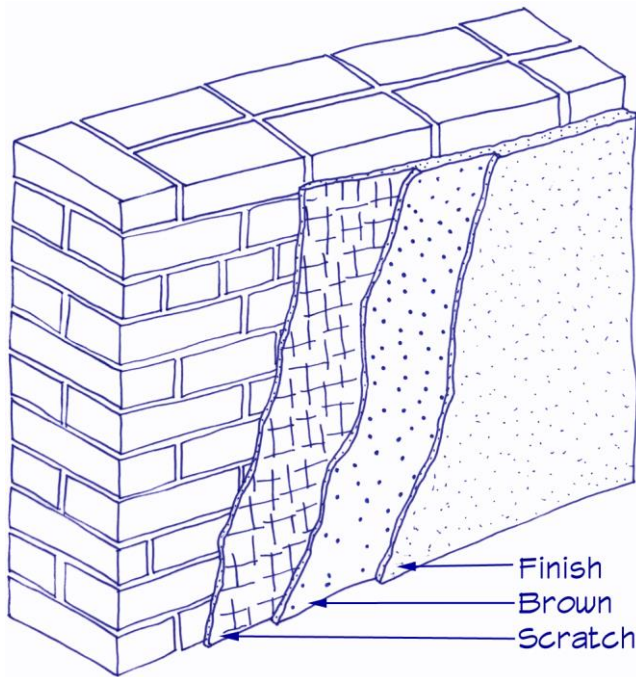
Traditionally stucco was applied in 3 layers; the scratch, brown and finish coats.

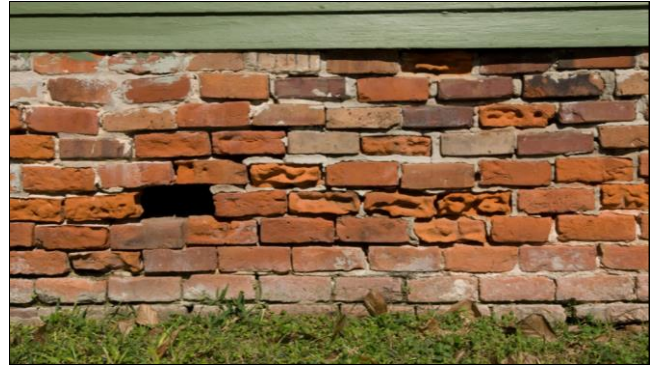
Deterioration of bricks and mortar at chain wall – *The surface of the bricks appear to be "melting" suggesting they are lake bricks. The mortar between the bricks is also eroding, increasing the potential for moisture infiltration.*

Recommendation – *Most chain walls, particularly those made from soft lake bricks should have a protective stucco coating. Replace missing brick. Repoint open joints with compatible mortar, as soon as possible, to minimize storm water entering wall. Apply compatible 3-coat stucco. Verify that the ground is sloping down away from the building and storm water is not pooling next to the foundation.*

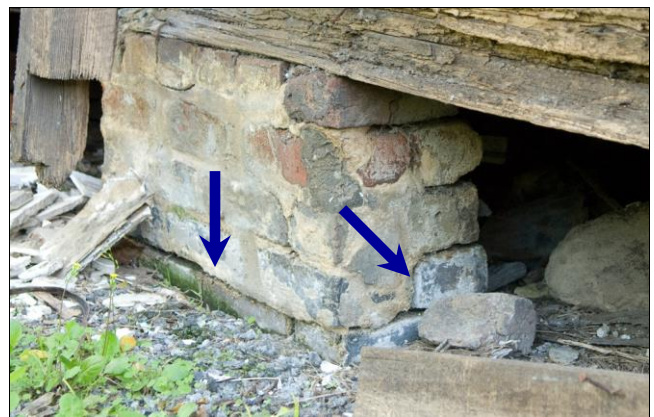
Open joints at brick pier – *The mortar is missing in the brick pier joints. This may be an indication of settlement or movement in the building.*

Recommendation – *Review the wall structure above the pier to verify whether the wood structure has shifted or is bulging or misaligned in response to pier movement. Repoint mortar joints with compatible mortar. Inspect pier every 3 to 4 months to see if joint has reopened, which would likely suggest the movement is still occurring.*

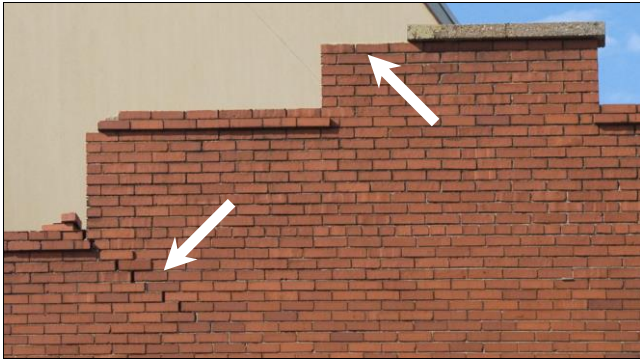
Missing parapet cap stone, stepped crack at wall – Part of the cast stone cap stone is missing at the top of the wall and there is a step crack following the mortar joints that suggests building movement.

Recommendation – Review wall structure to verify whether it has shifted or is bulging in response to movement or settlement. Repoint mortar joints with compatible mortar and install new matching cap stone to keep water from entering the top of the wall. Inspect crack every few months to see if joint has reopened, which suggests the movement is still occurring.

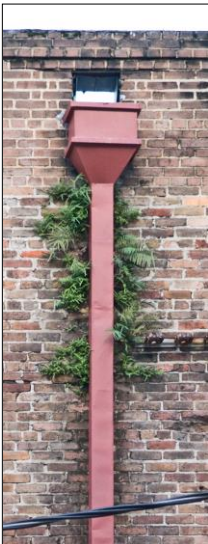
Plant growth and staining at downspout– Plants are growing in the mortar joints around the top of the downspout and there is dark brick staining below. Both conditions suggest the presence of moisture and saturation of the brick wall.

Recommendation –Verify that the downspout is clear and draining. Remove plant growth. Repoint open mortar joints with compatible mortar.

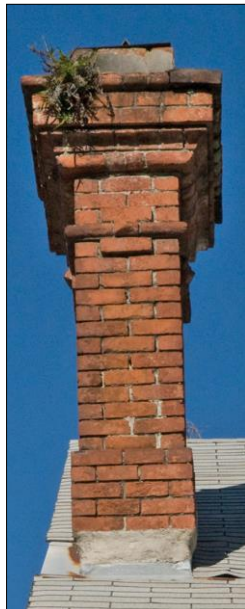
Leaning chimney– The chimney is leaning and has deteriorated bricks and eroded mortar.

Recommendation – Review chimney structure to verify whether it has shifted significantly and requires rebuilding to match existing. Remove plant growth. Repoint mortar joints with compatible mortar and install inverted “V” chimney cap or mortar wash at top of chimney to reduce water infiltration. Inspect crack every 3 to 4 months to see if joint has reopened, which would suggest continuing movement.

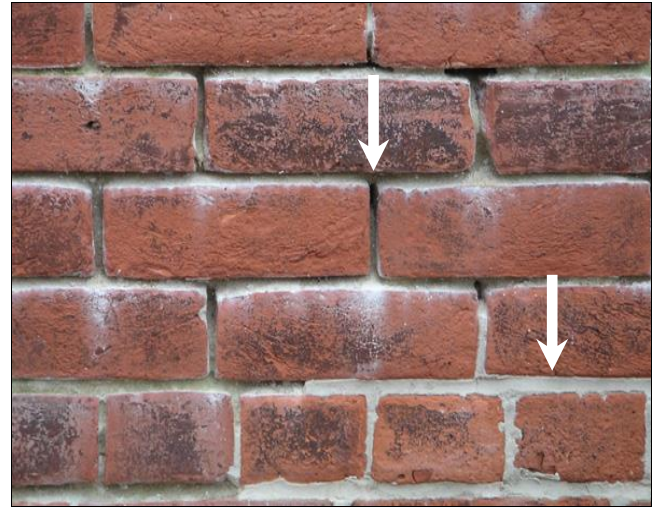
Disintegration of mortar from masonry surface – The mortar between the bricks has deteriorated particularly at the vertical joints, increasing the potential for moisture infiltration. The area at the lower right of the photograph has been recently repointed and mortar smeared into joints rather than properly tooled.

Recommendation – Repoint open joints with compatible mortar as soon as possible to minimize storm water entering wall. Consider repointing lower right section to ensure a tight bond with compatible mortar.

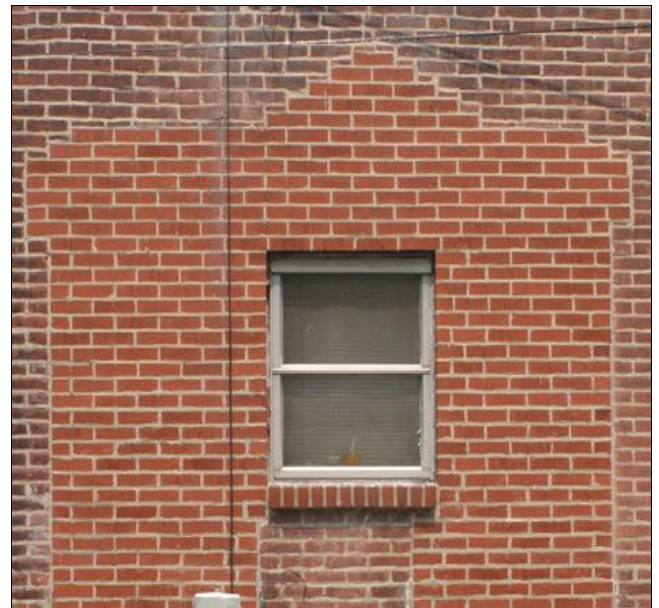
Masonry infill areas – The brick infill area is clearly visible. The infill area uses bricks of a different size and color than the historic bricks and is outlined by a thicker mortar joint rather than being “keyed” into the adjacent brickwork.

Recommendation – The bricks and mortar used in the infill areas should be the same size, color, texture, appearance, profile and hardness as the adjacent historic bricks. The repair should also be “toothed” into the adjacent brick to appear continuous with the wall surface.

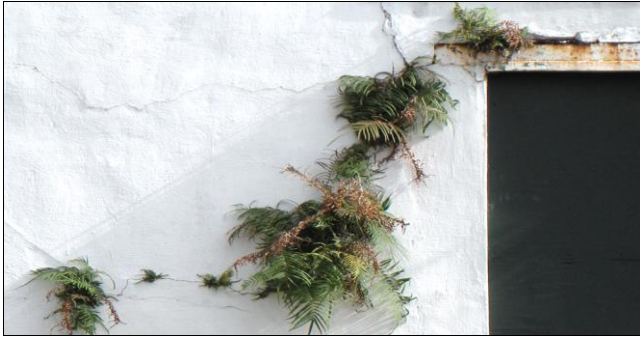
Plant growth in stucco crack – The cracks in the stucco are supporting plant growth suggesting moisture in walls. Also note the rusting lintel above the door.

Recommendation – The lintel is likely expanding due to the rust. Repair lintel, remove plants, repair crack and apply lime based masonry paint for a uniform appearance.

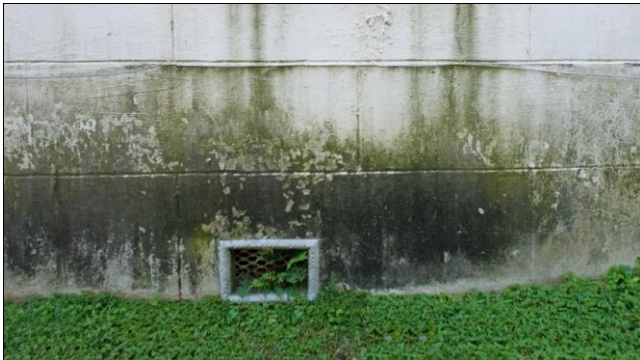
Algae growth at stucco foundation – The algae along the foundation suggests significant moisture in the ground immediately next to the building. Continued moisture can cause the stucco to delaminate, and fall off the wall.

Recommendation – Verify that the slope of the ground next to the foundation is draining away from the building and that no downspouts are discharging next to the area. Clean stucco and if required apply lime based masonry paint for a uniform appearance.

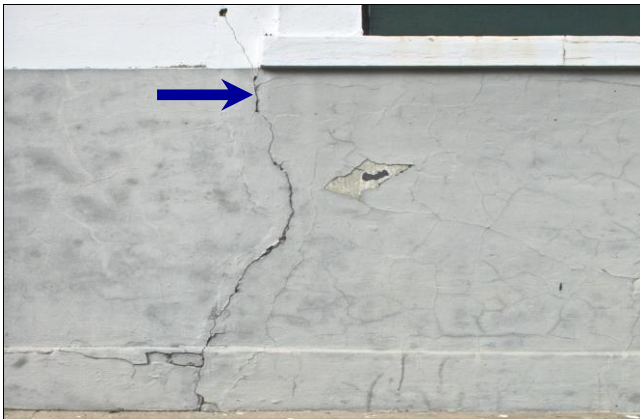
Stucco cracking– The crack from the window sill might be an indication of building movement.

Recommendation – Review wall for other signs of movement and/or settlement. Repair crack and apply lime based masonry paint for a uniform appearance.

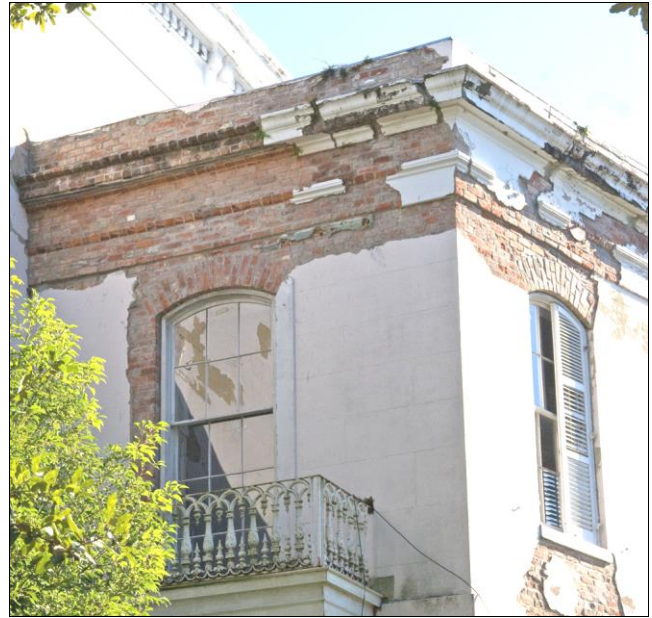
Stucco removed near roof – Stucco was often used as a less expensive means of achieving the prominence and grandeur of masonry. In this example, the stucco was scored to resemble stones and molded to form the details of the window surrounds and cornice. The failure of the stucco has exposed the soft, underlying brick to the elements.

Recommendation – Verify whether there is a roof drainage issue that caused the stucco to fail. Apply compatible stucco to match historic profiles and finish and lime based masonry paint for a uniform appearance.

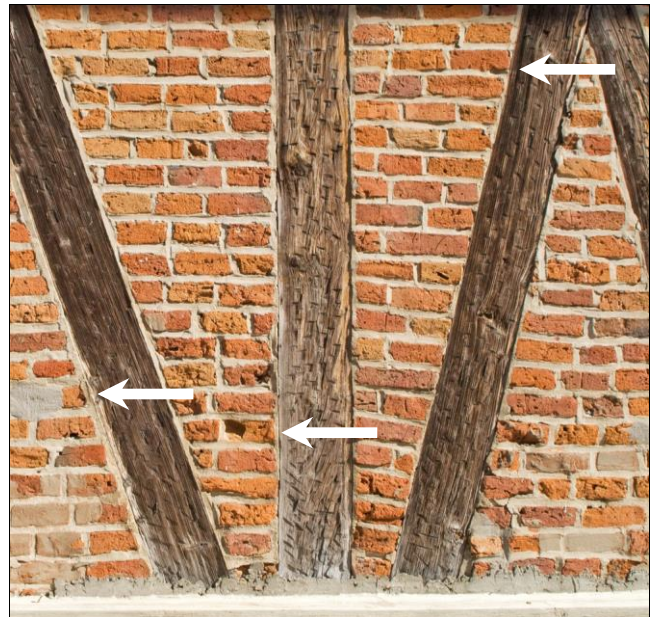
Stucco removed at brick between post construction – The removal of the stucco has exposed the soft, underlying brick to the elements. The brick is deteriorating quickly. Note the spalling and delamination of the brick surfaces, open joints and stucco patches replacing prior bricks.

Recommendation – Apply compatible stucco and lime based masonry paint for a uniform appearance.

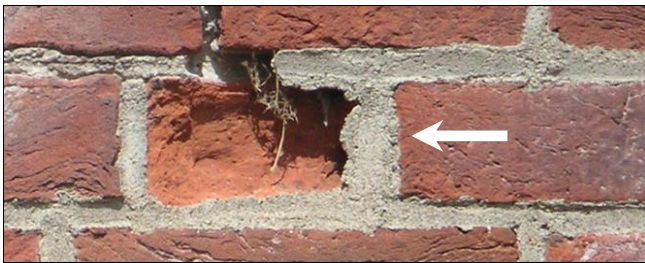
Spalling of the masonry surface – *The center brick surface has spalled. The repointing mortar likely includes too much Portland cement and is harder than the bricks. The mortar should be removed and replaced with soft mortar.*

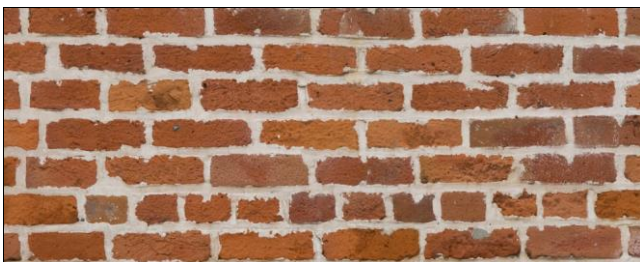
Widened and extended joints – *A power tool was used to cut-out the joints during repointing, extending vertical joints. The joints have also been widened and are too large.*

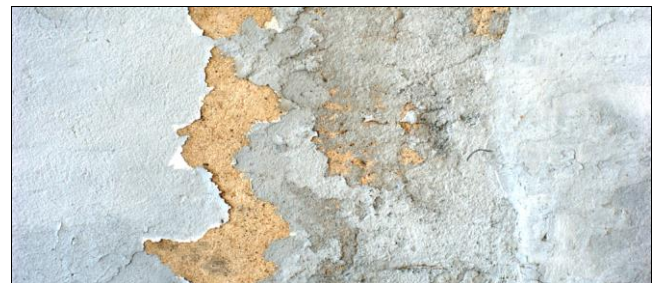
The peeling paint is likely incompatible with the stucco or caused by moisture. Loose and flaking paint should be removed and the cause for failure addressed before repainting.

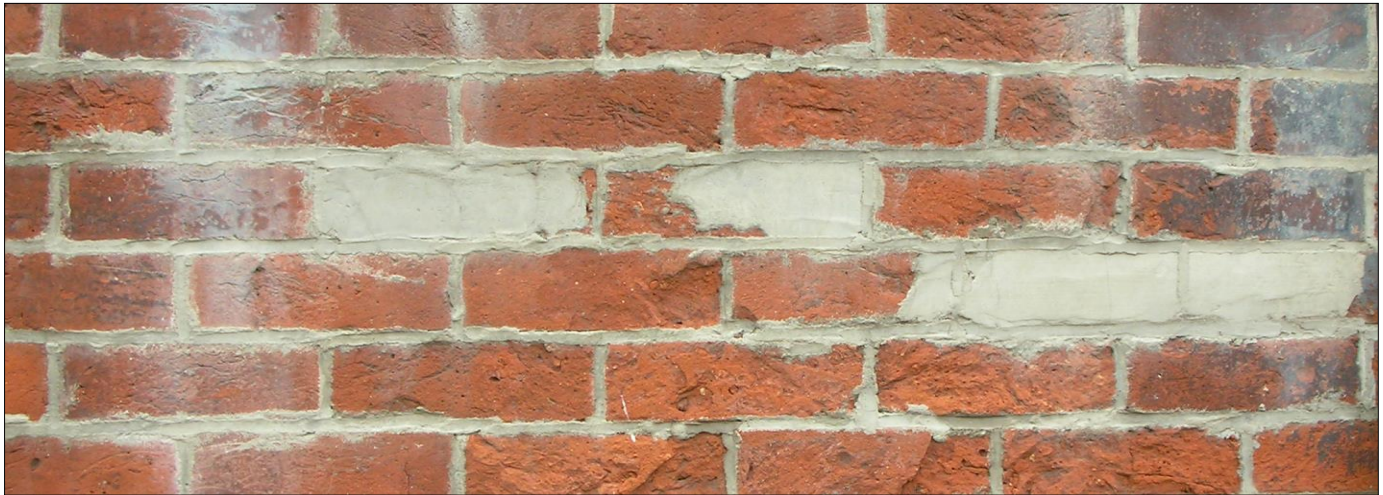
The rough texture and uneven surface suggest that an aggressive cleaning method was used. Stucco patches replace bricks and efflorescence, a white powdery substance, can be seen on the surface.

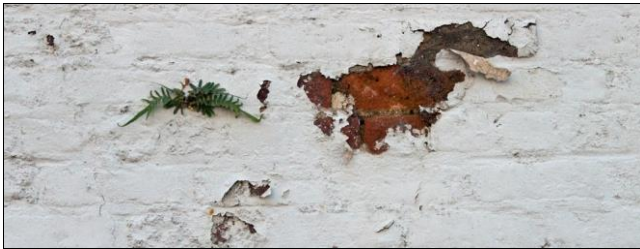
The peeling paint is likely incompatible with the brick or may be caused by moisture. The plant growth indicates moisture trapped in the wall. The paint should be removed.
